REPORT OF FINDINGS
TO THE
RAYMOND SCHOOL BOARD
ON THE PLAN FOR
LAMPREY RIVER
ELEMENTARY SCHOOL

**REPORT OF FINDINGS
LAMPREY RIVER ELEMENTARY SCHOOL**

Barker Architects, PLLC, completed a Facility Assessment Study² of the existing Lamprey River Elementary School Building and Property to evaluate the current condition of the facility and property, to determine current programming needs and requirements, to identify required educational program needs and requirements, to identify code requirements that to provide options for review o .

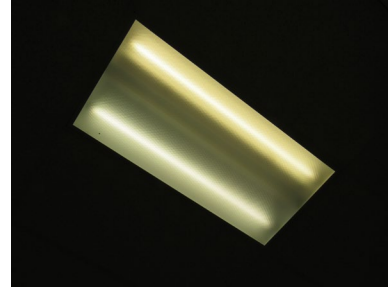
Aging Light Fixture

Many of the light fixtures have been upgraded but with technology changing rapidly it is probably time for another upgrade. When they were upgraded the ballasts and lamps were changed but the housing and lenses were not. The lenses have yellowed and do not supply very good quality light. Entirely new LED fixtures is recommended.
