**RAYMOND
SCHOOL DISTRICT**

**LAMPREY RIVER
ELEMENTARY SCHOOL**

FACILITY ASSESSMENT STUDY

JULY 6, 2020

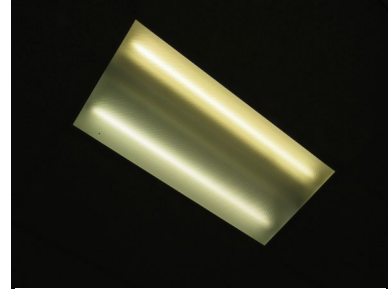
Aging Light Fixture

Many of the light fixtures have been upgraded but with technology changing rapidly it is probably time for another upgrade. When they were upgraded the ballasts and lamps were changed but the housing and lenses were not. The lenses have yellowed and do not supply very good quality light. Entirely new LED fixtures is recommended.
