**RAYMOND
SCHOOL DISTRICT**

**LAMPREY RIVER
ELEMENTARY SCHOOL**

FACILITY ASSESSMENT STUDY

JULY 6, 2020

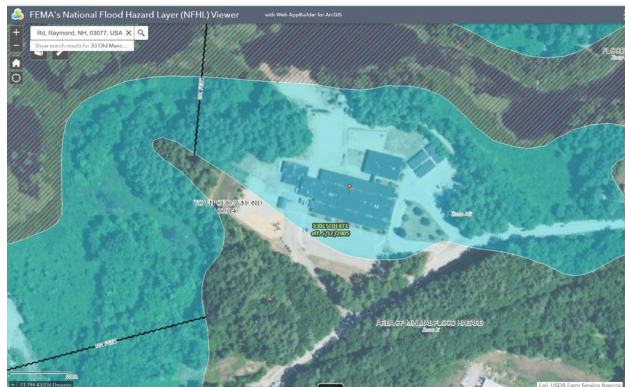
FEMA Floodplain Map of LRES

When it was first constructed LRES was likely not built within the floodplain, but FEMA revised the estimated flood levels effective 5/17/2005 and the building is now entirely within the floodplain. The floor level itself is 1'-2" above the anticipated flood level but the surrounding grade is below it. This has proven correct in the last two floods in 2005 and 2006. The town of Raymond has adopted an ordinance that requires new construction to be 1'-6" above the floodplain.

The issue is not simply meeting code but also if it is good judgement to have a large community asset such as LRES located in the floodplain. The 100-year flood line is an estimated maximum but could be exceeded. If it is, the damage to books, materials, computers, electrical system, finishes and the structure itself could be significant. Also, schools are often a place for shelter in emergencies and having LRES surrounded by flood could put people who rely on using this building at risk. There is not an easy answer to this issue.

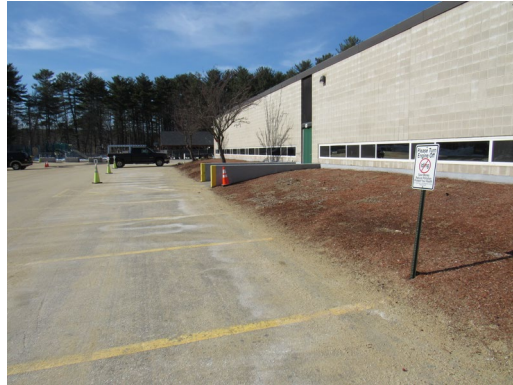
The driveway system appears to be working but should be improved. There is limited signage and the route to the front entrance is not immediately clear. It often creates a conflict with individuals accessing the building while busses are loading or unloading. Parent drop-off and pick-up is well organized but labor intensive. The loading zone occupies a large area of parking. There are no sidewalks or curbs, so the staff rely on pylons and jersey barriers to keep students safe from moving cars.

Parent Pick-Up Zone Through Parking

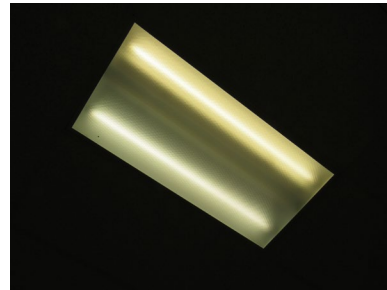
Aging Light Fixture

Many of the light fixtures have been upgraded but with technology changing rapidly it is probably time for another upgrade. When they were upgraded the ballasts and lamps were changed but the housing and lenses were not. The lenses have yellowed and do not supply very good quality light. Entirely new LED fixtures is recommended.

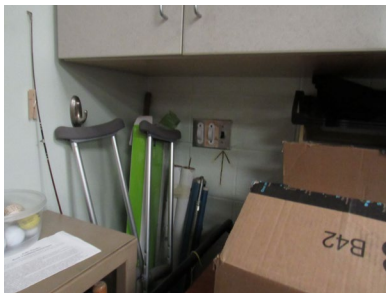
Light Switch Remote from Door

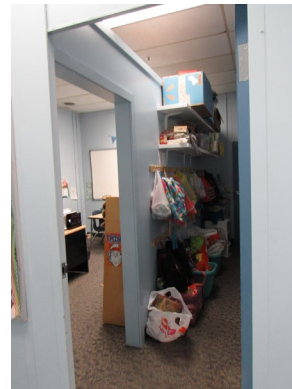
Office space appears to be adequate, but this is deceiving because the arrangement is inefficient. There are circulation areas through offices making usable space small. The nurse's office does not have enough room to provide appropriate privacy.

Office with Lack of Privacy
