Lamprey River Elementary School

Facilities Impact Committee

Fact Finding Report

September 17, 2008

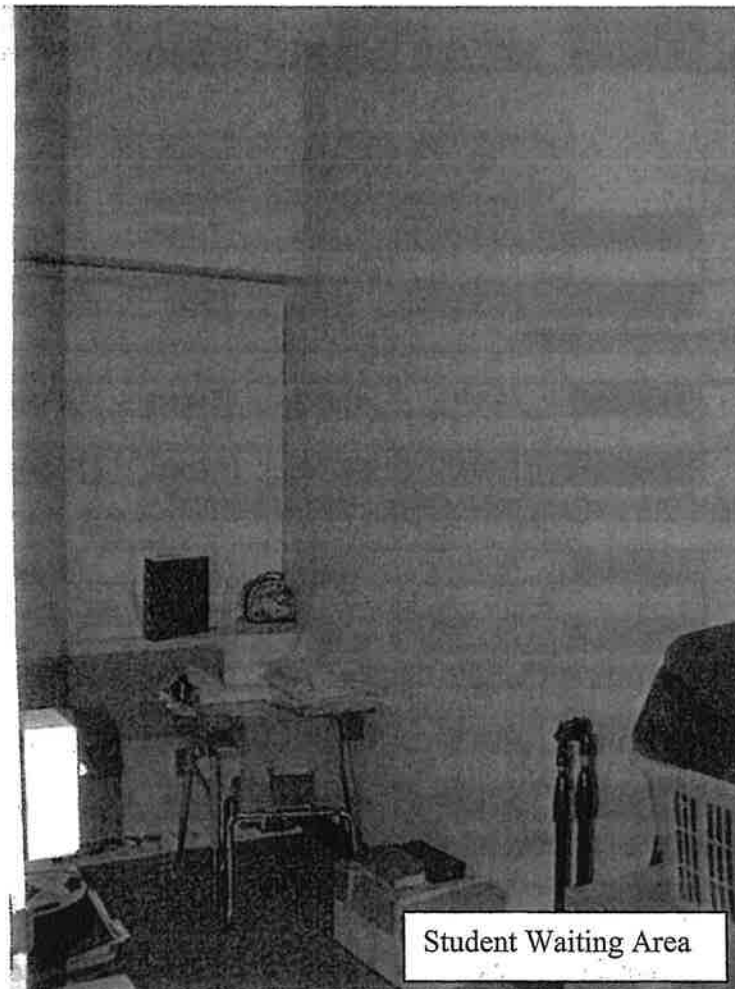
LRES currently houses three administrative offices; the principal's office, the assistant principal's office, and the special education coordinator's office. The principal's office measures 165 sq. ft., the assistant principal's office measures 121 sq. ft., and the special education coordinator's office measures 120 sq. ft. All administrative offices meet the state requirement of being a private office space per *the NH Code of Administrative Rules Ed 321.12(b)*.

Attached to the assistant principal's office is a student waiting area measuring 60 sq. ft.

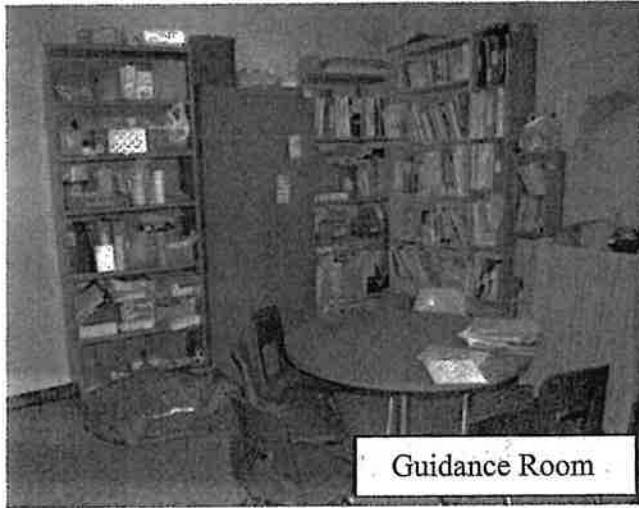
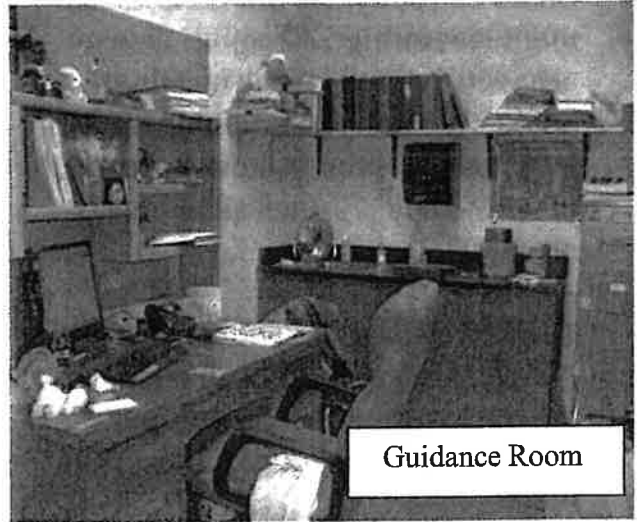
There are two guidance offices at LRES. One guidance office measures 240 sq. ft., while the second measures 128 sq. ft.

The *Manual for Planning and Construction of School Buildings (2006)* requires that guidance offices be a minimum of 100 sq. ft. and provide a conference room for meetings for up to twelve people. The guidance department does not have a conference room.

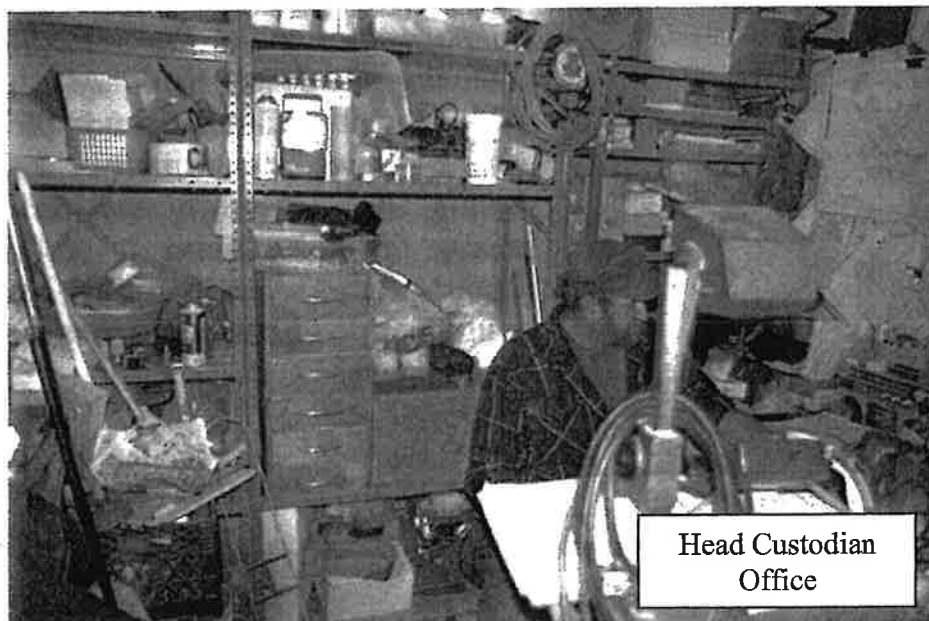
The head custodian's office at LRES is located in the custodial room. The *Manual for Planning and Construction of School Buildings (2006)* requires that schools have a separate custodian's office. LRES does not meet this requirement.

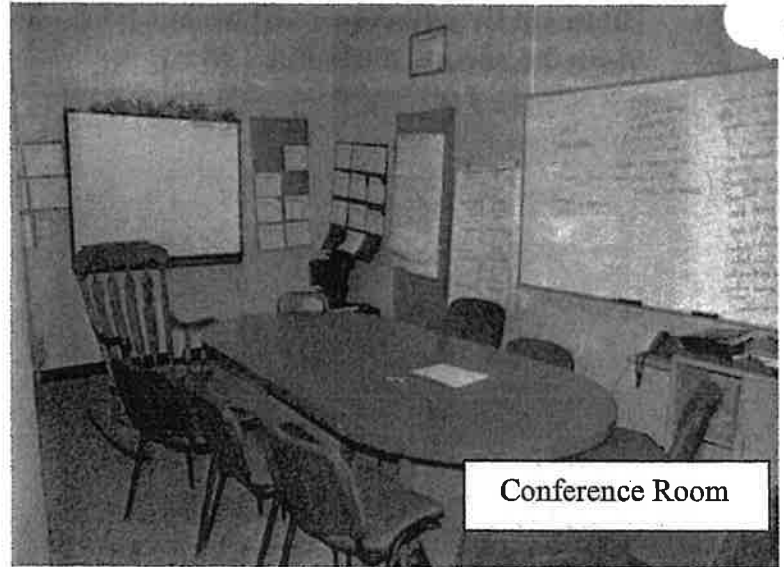
Conference Room

LRES currently has one conference room measuring 247 sq. ft. Due to necessity, simultaneous meetings occur which displace administrative personnel. Of the 160 days observed in 2007-2008, 72 such situations occurred.

The *NH Code of Administrative Rules Ed 321.11* requires that an area for private meetings for parents and staff shall be available. LRES meets this requirement.

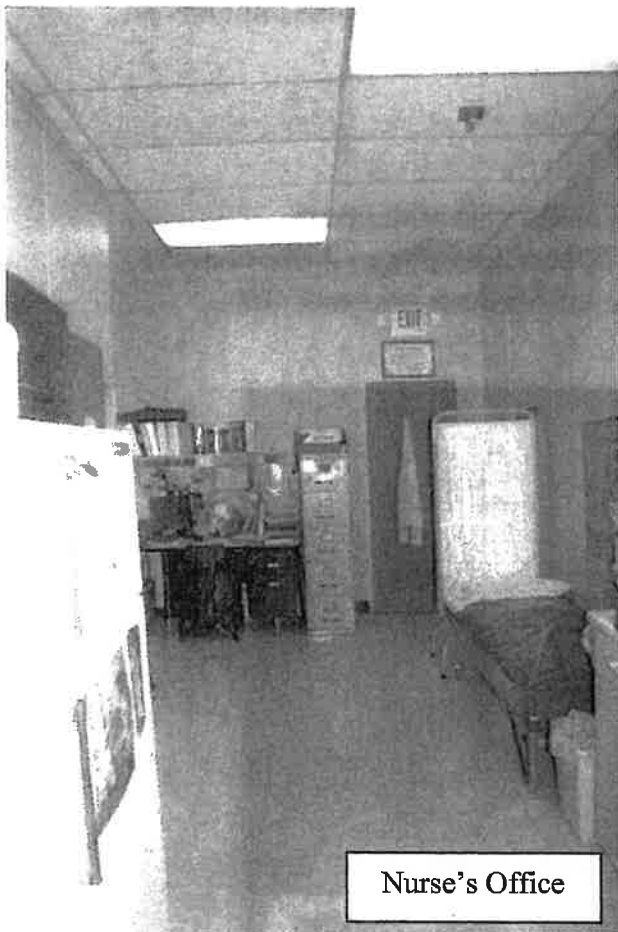
Nurse's Office

LRES currently has one nurse's office measuring 264 sq. ft. in size consisting of 1 cot per 585 students, a waiting area in the hallway, one sink, one restroom (non-handicap accessible), and desk space for the nurse and her assistant.

According to the *NH Code of Administrative Rules Ed 321.12(c)*, the following standards shall apply: nurse's space should be a minimum of 300 sq. ft., an exclusive administrative space, a waiting area, secure dry and refrigerated storage for medications, 1 cot per 200 pupils and a handicapped accessible bathroom. LRES does not meet these requirements.

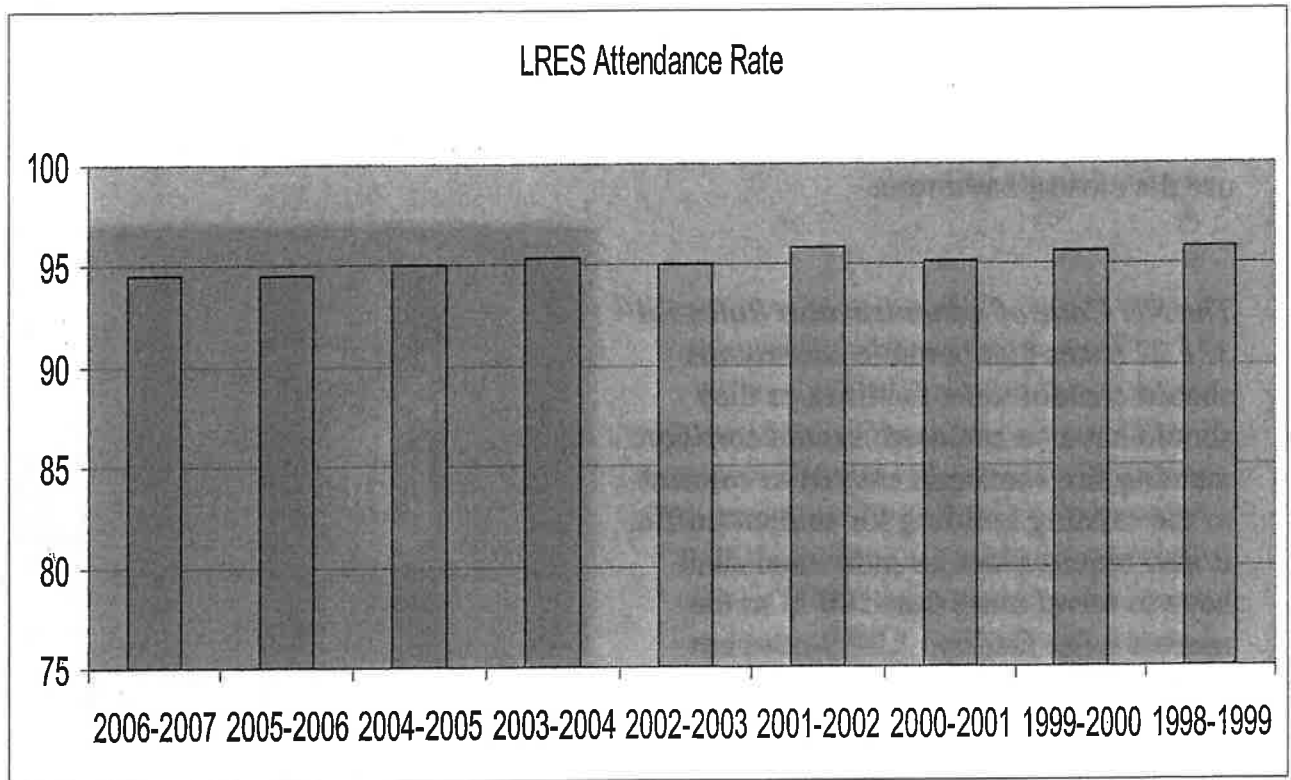
Figure 2:

Figure 2 shows the average daily attendance rate for Lamprey River Elementary School for the school years 1998-1999 through 2006-2007. The figures include grades 1-4 only (Grade 4 arrived in 2002-2003).

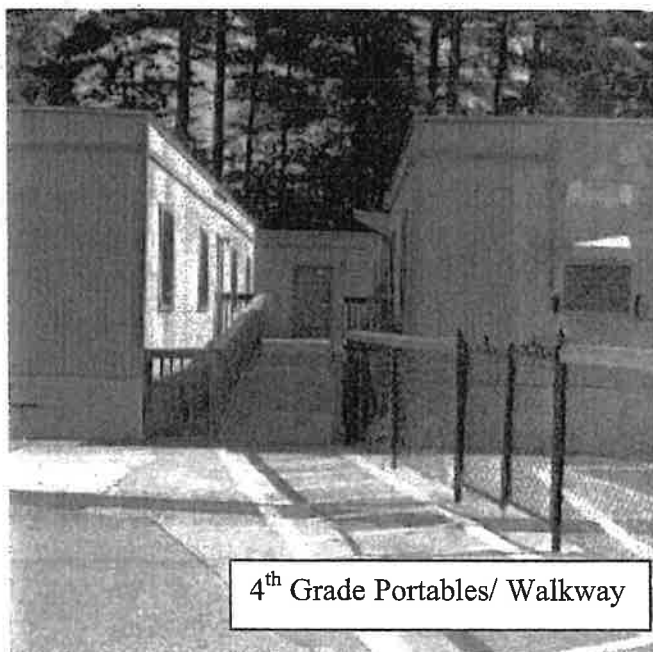
4th Grade Portables/ Walkway

However, there are no bathrooms in the detached portables. This requires the fourth graders, located in these portables, to go 275 feet into the main building to use the closest bathroom.

The NH Code of Administrative Rules Ed 321.22 states that portable classrooms should contain toilet facilities or they should have an enclosed, heated corridor, meeting fire standards erected to connect to the existing building for student traffic. It also requires that no individual shall have to travel more than 500 ft. to the nearest toilet facility. LRES does not meet the enclosed, heated corridor requirement.

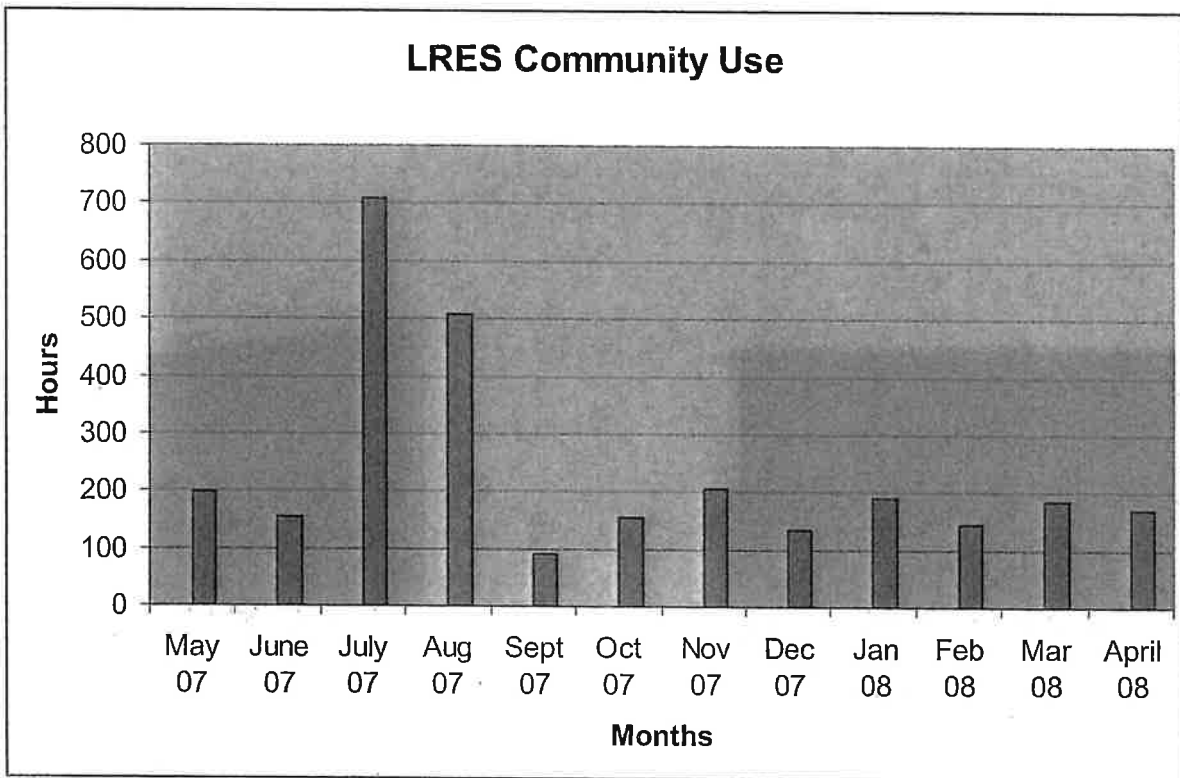
Figure 3:

A study of building use by the community was conducted from May 2007 through June 2008. Figure 3 shows the total hours LRES was used by the community each month. For example, the space is used by the after school program, scouts, rotary, recreation department, etc.

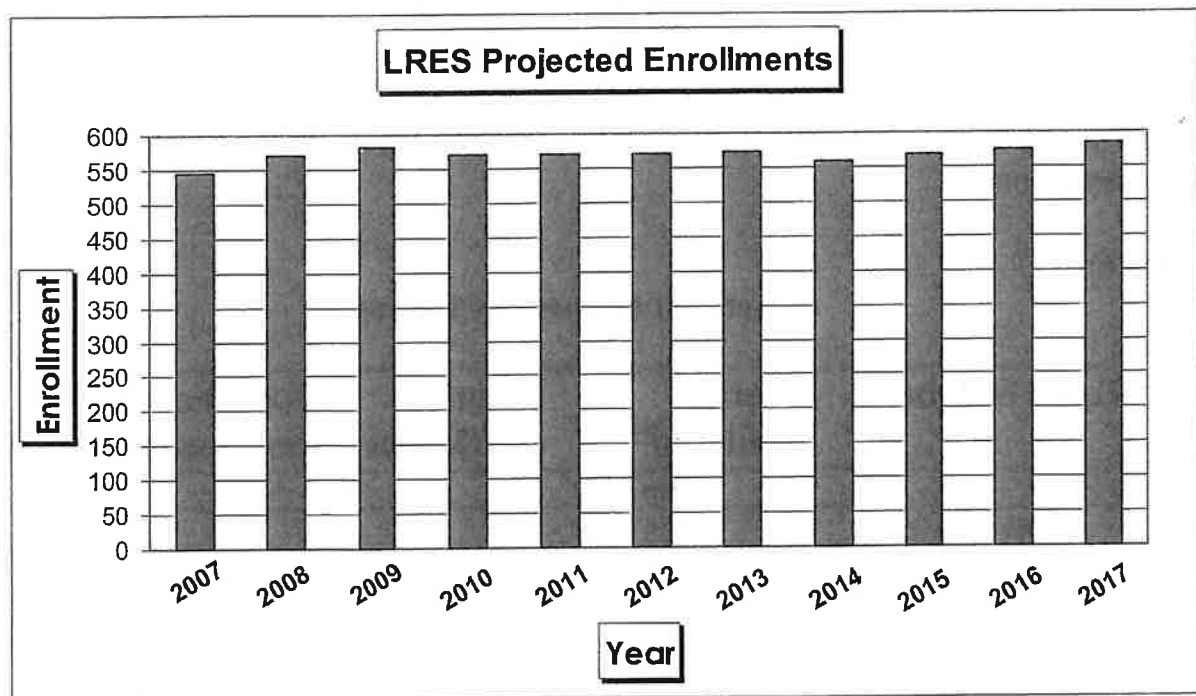
Figure 4:

Figure 4 shows LRES' enrollment projections for the next ten years. The October 2007 LRES Preschool-4 student enrollment was 589. The 2008 opening day enrollment Preschool-4 was 604 students. In 2017, LRES will see similar enrollment figures. The New Hampshire School Board Association (NHSBA) does the district's enrollment projections and the NHSBA uses three different methodologies to calculate their projections. The 2017 NHSBA student enrollment projections using the three different methodologies are as follows: simple projection is 583, five year projection is 518, and the three year weighted average projection is 546. (Pre-school is also housed at LRES and averages forty five students. The NHSBA does not factor in Pre-school).

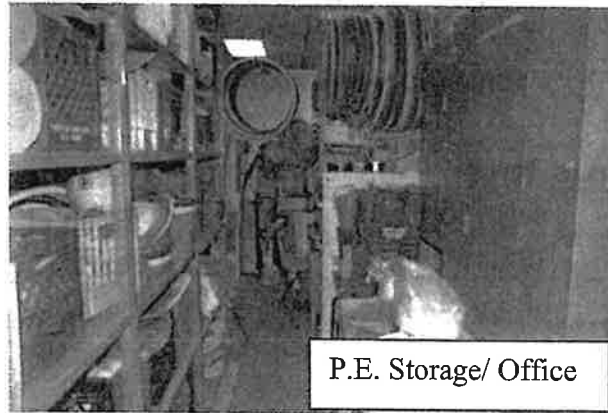
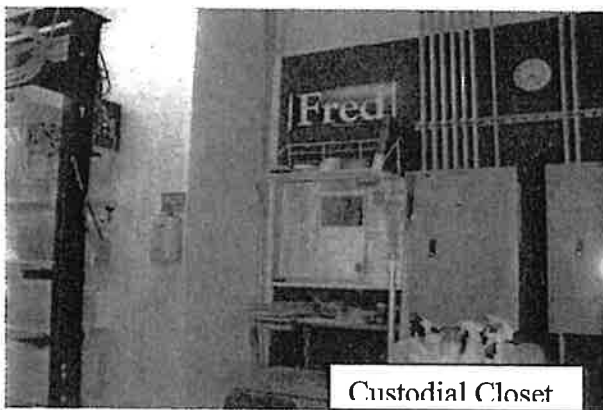
The custodial storage area currently houses all maintenance supplies, custodial supplies, custodial sink, the Head Custodian's office space, electrical panels, some school supplies and the Physical Education teacher's office and equipment. As mentioned previously, the LRES custodial office space does not meet requirements.

The second custodial closet houses electrical panels, the cleaning cart and cleaning supplies.

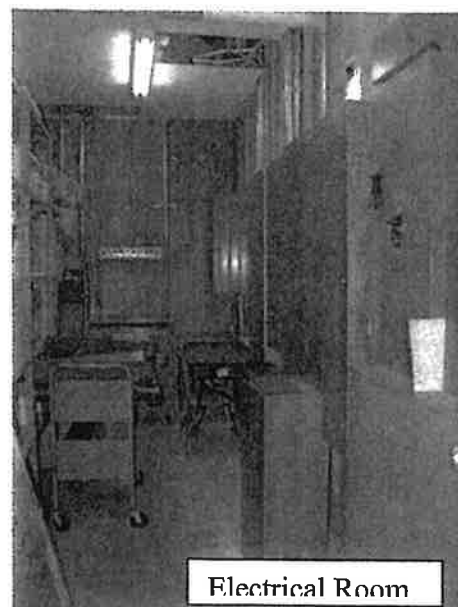
The third custodial closet/electrical room houses one custodial sink, hot water tank, electrical panels, fire alarm panel, cleaning cart and supplies, office supplies and nurse's storage.

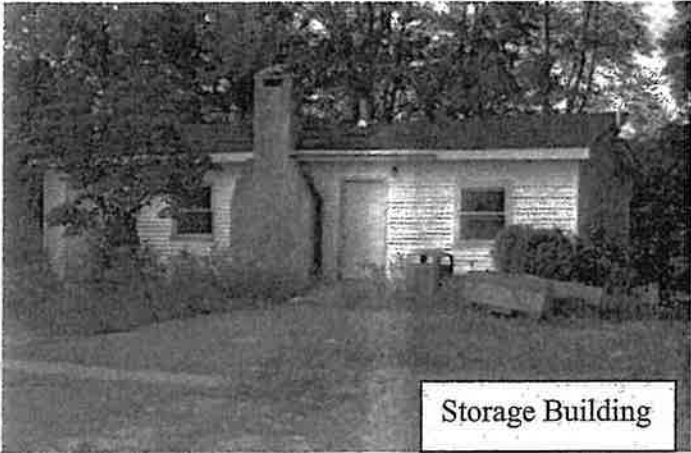
Storage Building

LRES currently uses hallway space, a storage trailer, and a free standing storage building for housing items such as desks, chairs, tables and other school furnishings. The storage building and storage trailer are cold storage. Because of this they cannot be used for files, paper, liquid products or products susceptible to moisture.

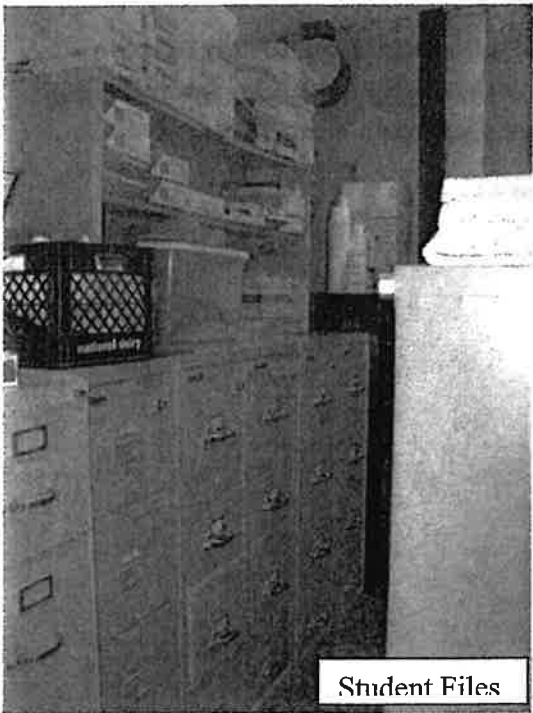
Student Files

The student file room measures 120 sq. ft. and is located in the interior of the main office. It houses the student files by grade, the special education files, the 504 files and the office supplies.

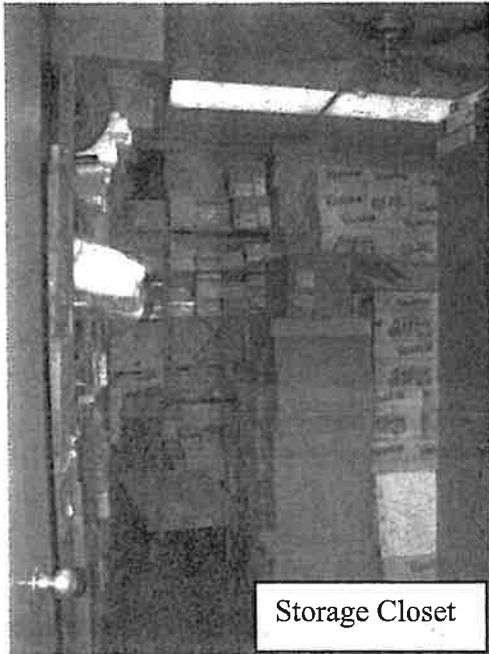
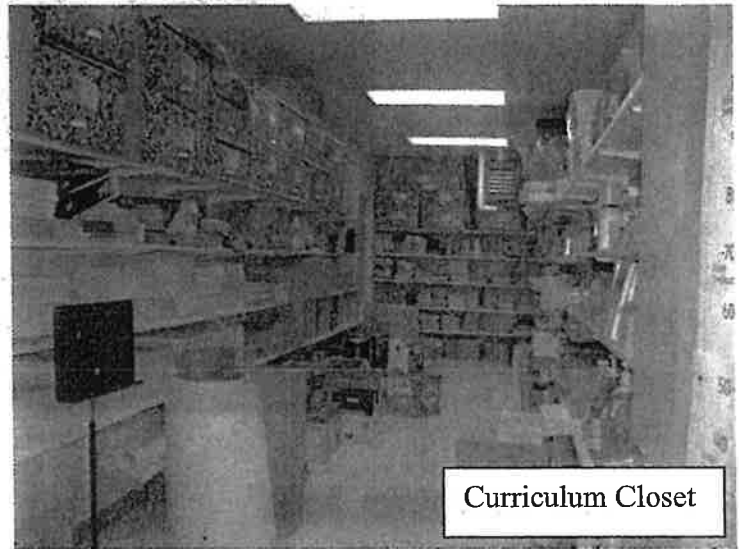
LRES currently has a variety of storage areas in an attempt to house school supplies. The main building has one storage room which houses classroom supplies and paper. The Kindergarten wing has one storage room for school wide curriculum materials and supplies.

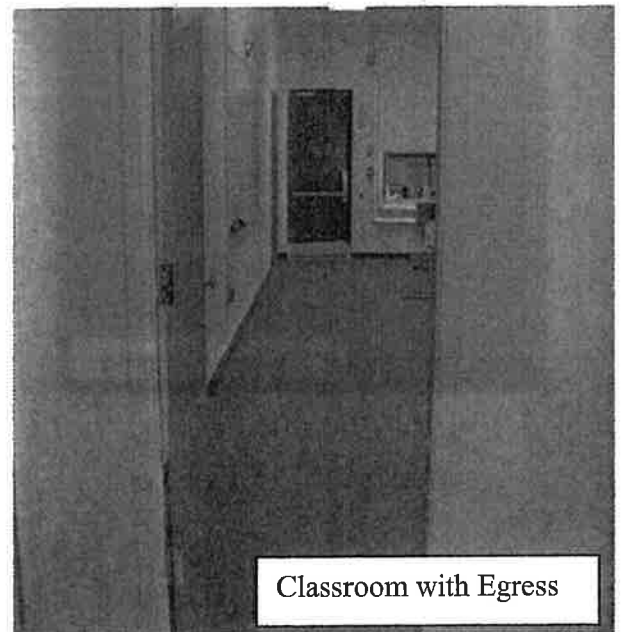
There are currently three classrooms that have an emergency egress through a section of classroom space. The National Fire Prevention Association codes require a 36 in. wide unobstructed path between the emergency door and classroom entrance. LRES meets this requirement; however the emergency egress decreases classroom flexibility.

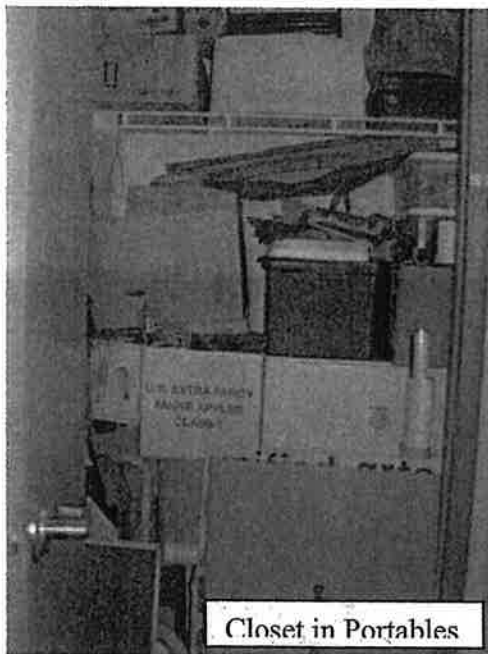
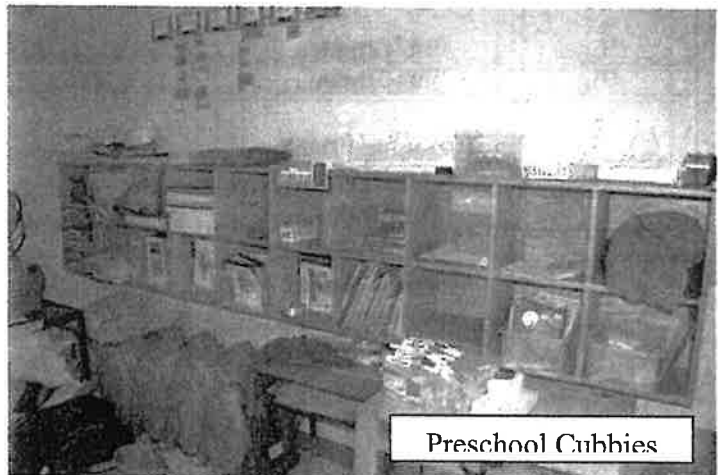
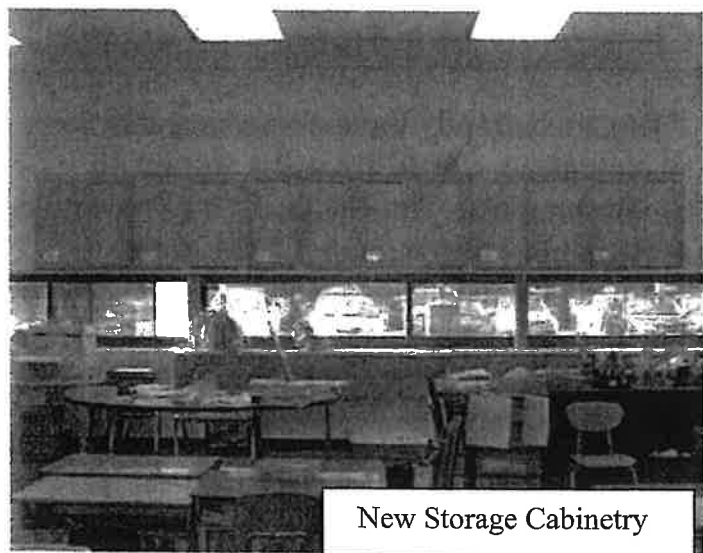
At LRES there are a total of thirty eight classrooms. Twenty three classrooms do not have built-in storage. The teacher supplies for instruction are stored in cardboard boxes, plastic totes, rolling cabinets or metal shelving. Fifteen classrooms have some form of built-in storage. The six detached portables each have a built-in closet with one shelf. The six classrooms in the Kindergarten wing each have built-in wall shelves and one built-in closet which are attached to a counter unit with drawers. One classroom in the main building has attached wall cabinets. The computer lab has a storage closet. The reading room has a storage closet.

All grade level classes have wall mounted coat hooks. The Kindergarten and pre-school classes have wall mounted cubbies as well.

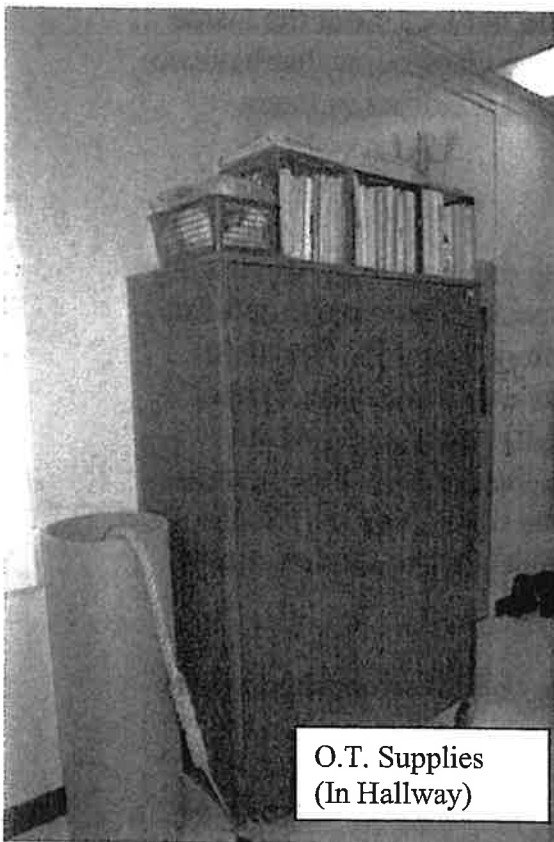
O.T. Supplies
(In Hallway)

LRES has one 168 sq. ft. room shared by an Occupational Therapist and a Certified Occupational Therapy Assistant. The room has a therapy swing attached to the ceiling, which needs a minimum of 14 ft. to 16 ft. to swing without hitting the walls or door. The room measures 12 ft. by 14 ft. Therapy on scooter boards is done in the hallway outside the office. Equipment and supplies for occupational therapy are stored throughout the building.

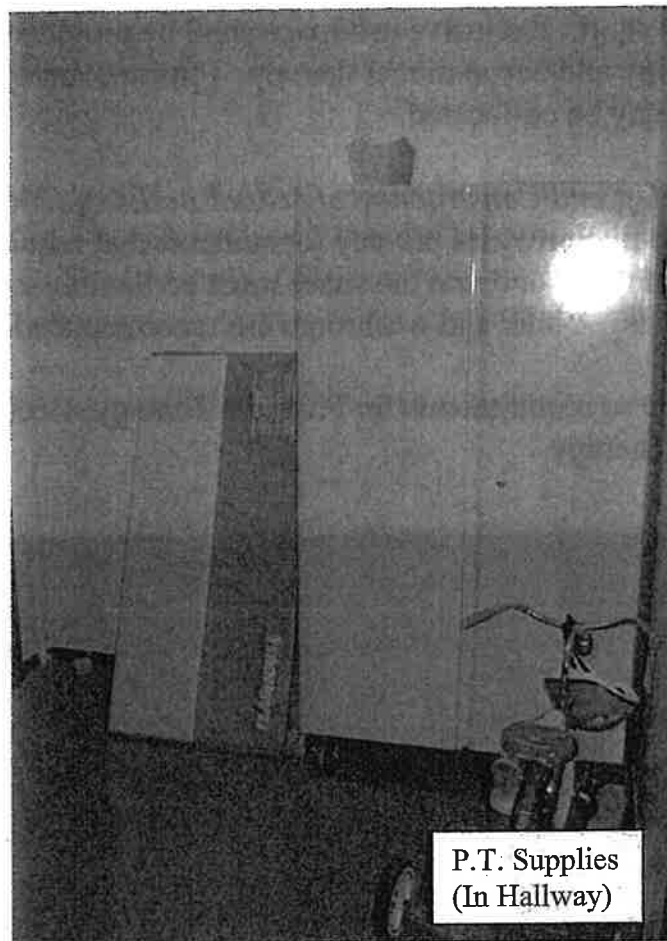
There is no dedicated space for physical therapy, so therapy is provided in the hallway. Physical Therapy equipment and supplies are stored throughout the building.

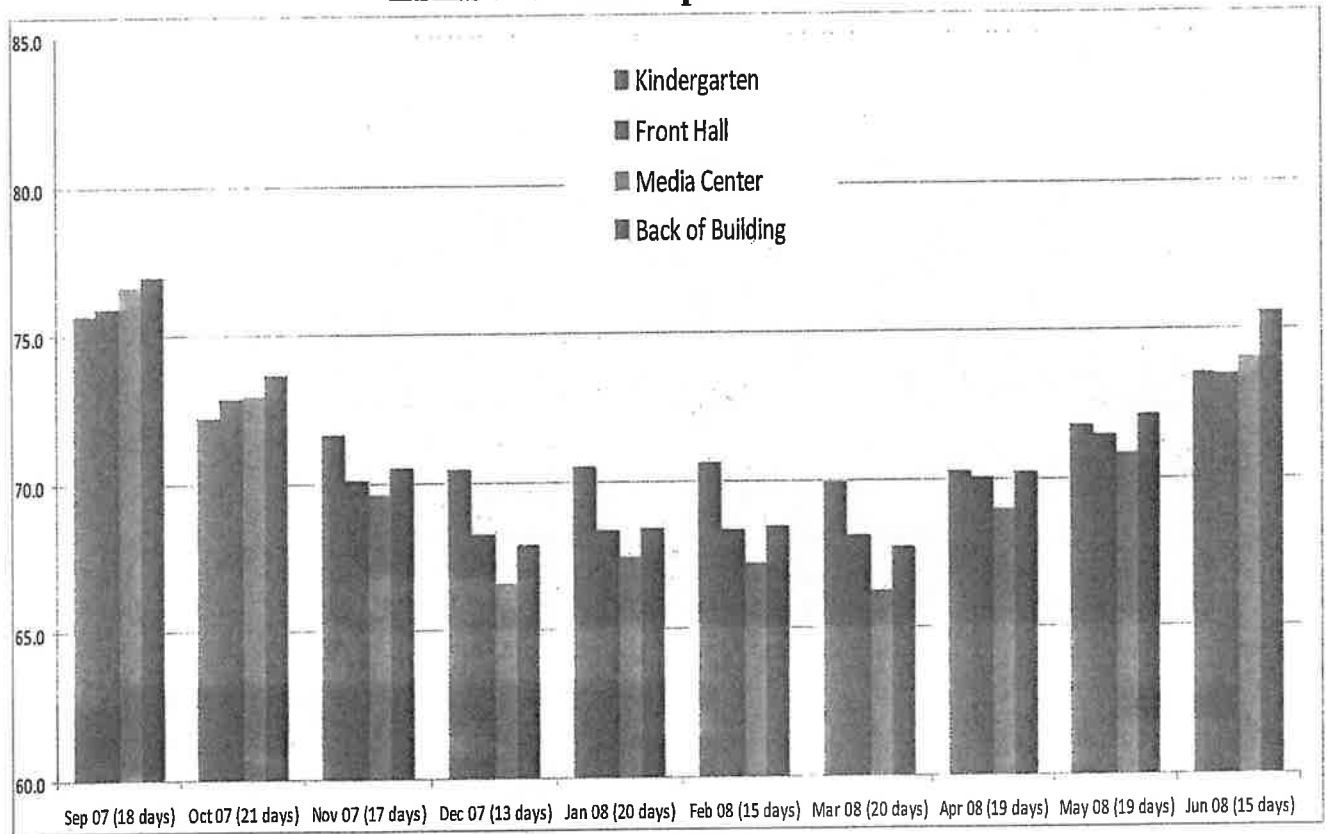
Figure 9:

Figure 9 shows the average daily temperature in four locations of Lamprey River Elementary School. Temperatures range from a high of 77 degrees to a low of 66.3 degrees. LRES does not meet the recommended comfort levels at certain times of the year (see Figure 1).

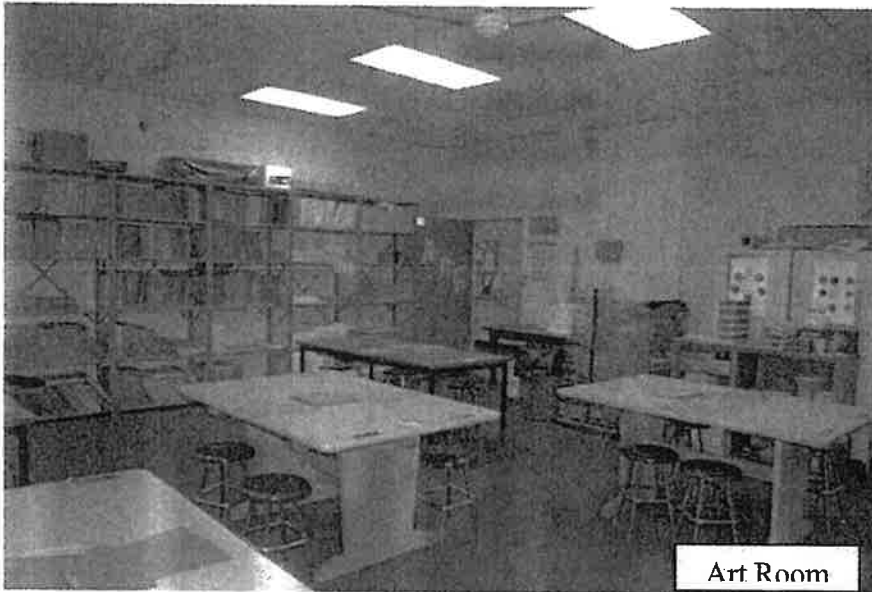
The art room has its own dedicated classroom but does not have a storage closet for supplies.

The Manual for Planning and Construction of School Buildings (2006) requires that the art education space be 30 square feet per pupil, have a ventilation rate of at least 20 cubic feet per minute per person, and a walk-in storage closet opening off of the main room is a necessity. LRES meets the size and ventilation requirements but does not meet the walk-in storage requirement.

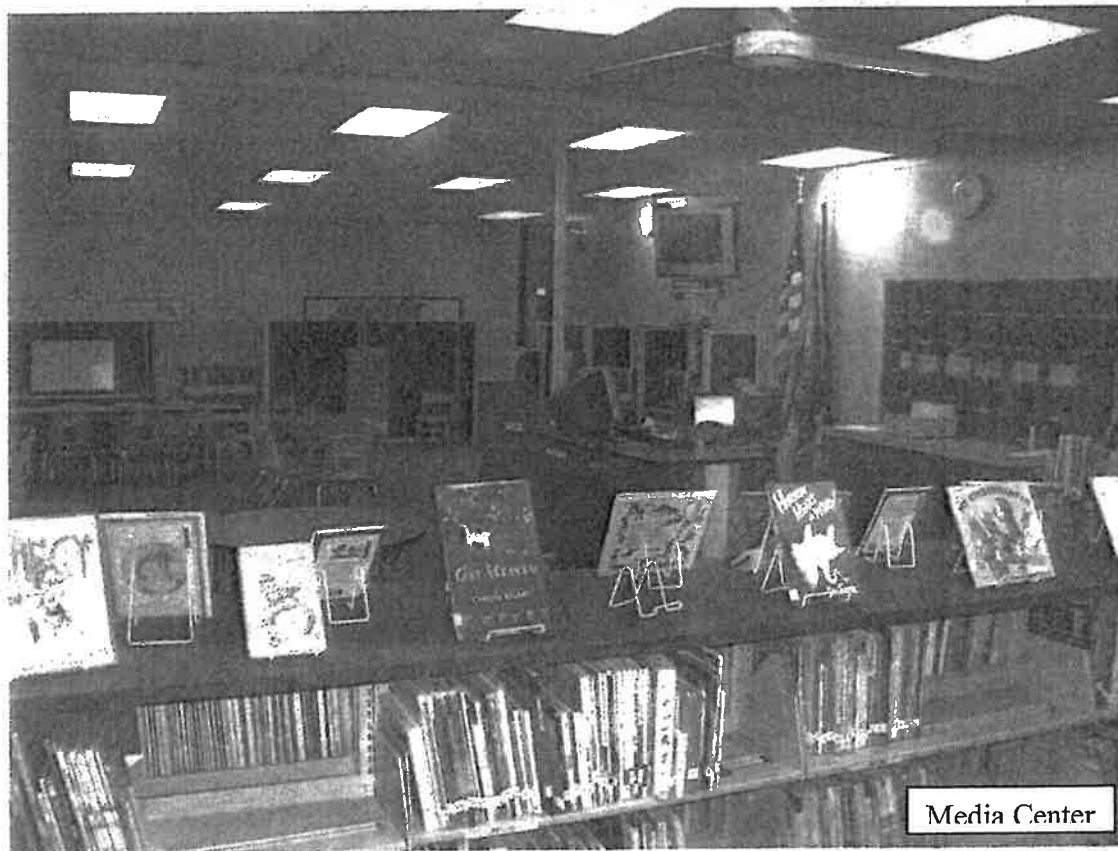
The media center is an open concept space with one wall. The three other sides consist of bookshelves and partitions, partially open to the hallways. The media center is 1640 sq. ft. and contains a circulation desk, bookshelves, and tables.

LRES does not meet any of these requirements.

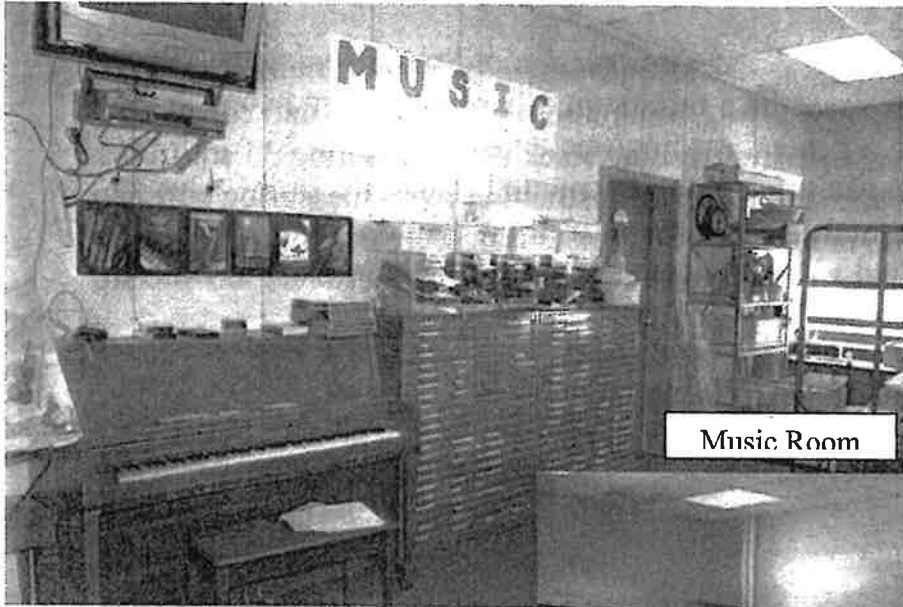
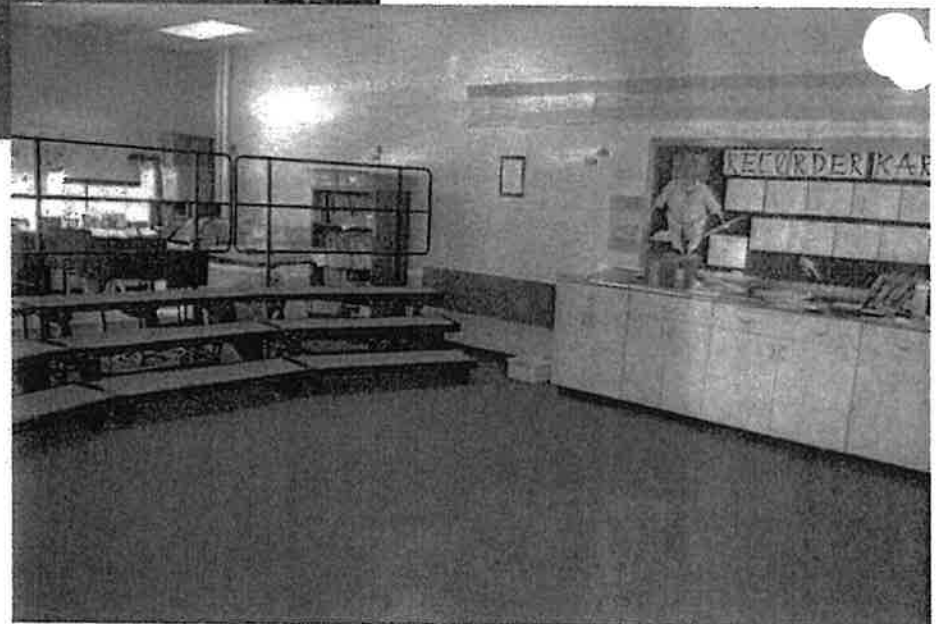
The music room has its own dedicated classroom and contains one sound dampening wall, two exterior walls, and one hallway wall. The sound has an impact on the classroom next door.

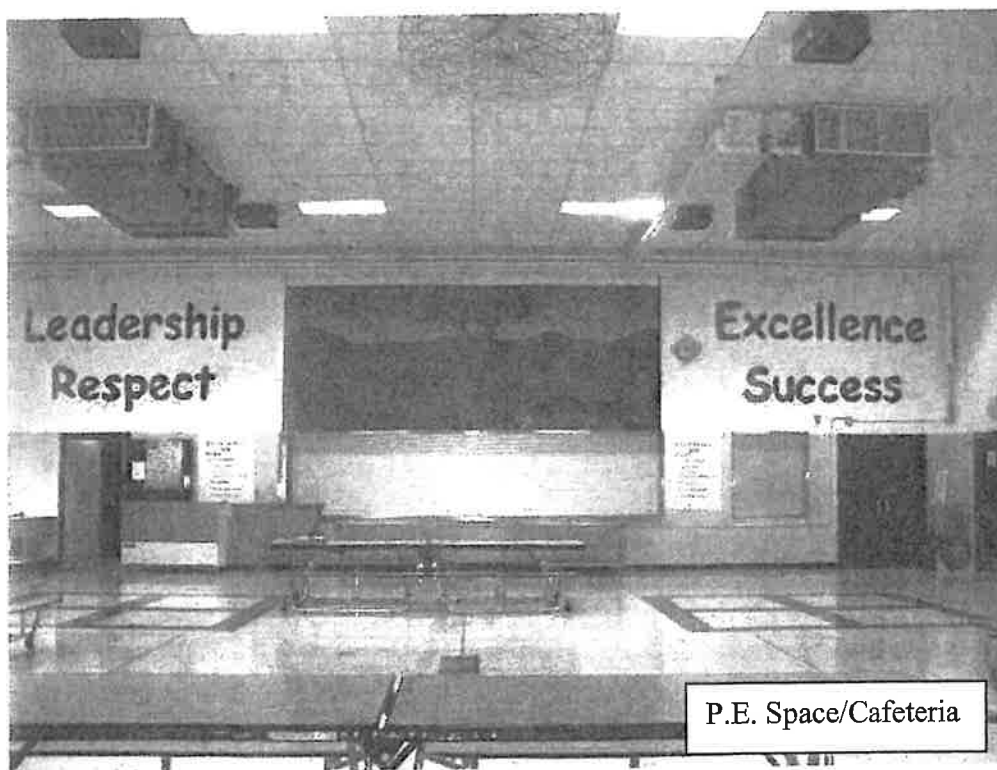
The physical education program is currently run in the shared cafeteria space as well as outside when weather permits. The size of the physical education space is 3,120 sq. ft. Due to the school lunch schedule, the cafeteria cannot be used during the day from 11:15 AM - 2:15 PM; therefore, 7 out of 25 classes per week are held in the classroom. Other conflicts include grade level assemblies and preparation for after school activities.

LRES does not meet the sq. ft. requirement.
