**RAYMOND
SCHOOL DISTRICT**

**LAMPREY RIVER
ELEMENTARY SCHOOL**

FACILITY ASSESSMENT STUDY

JULY 6, 2020

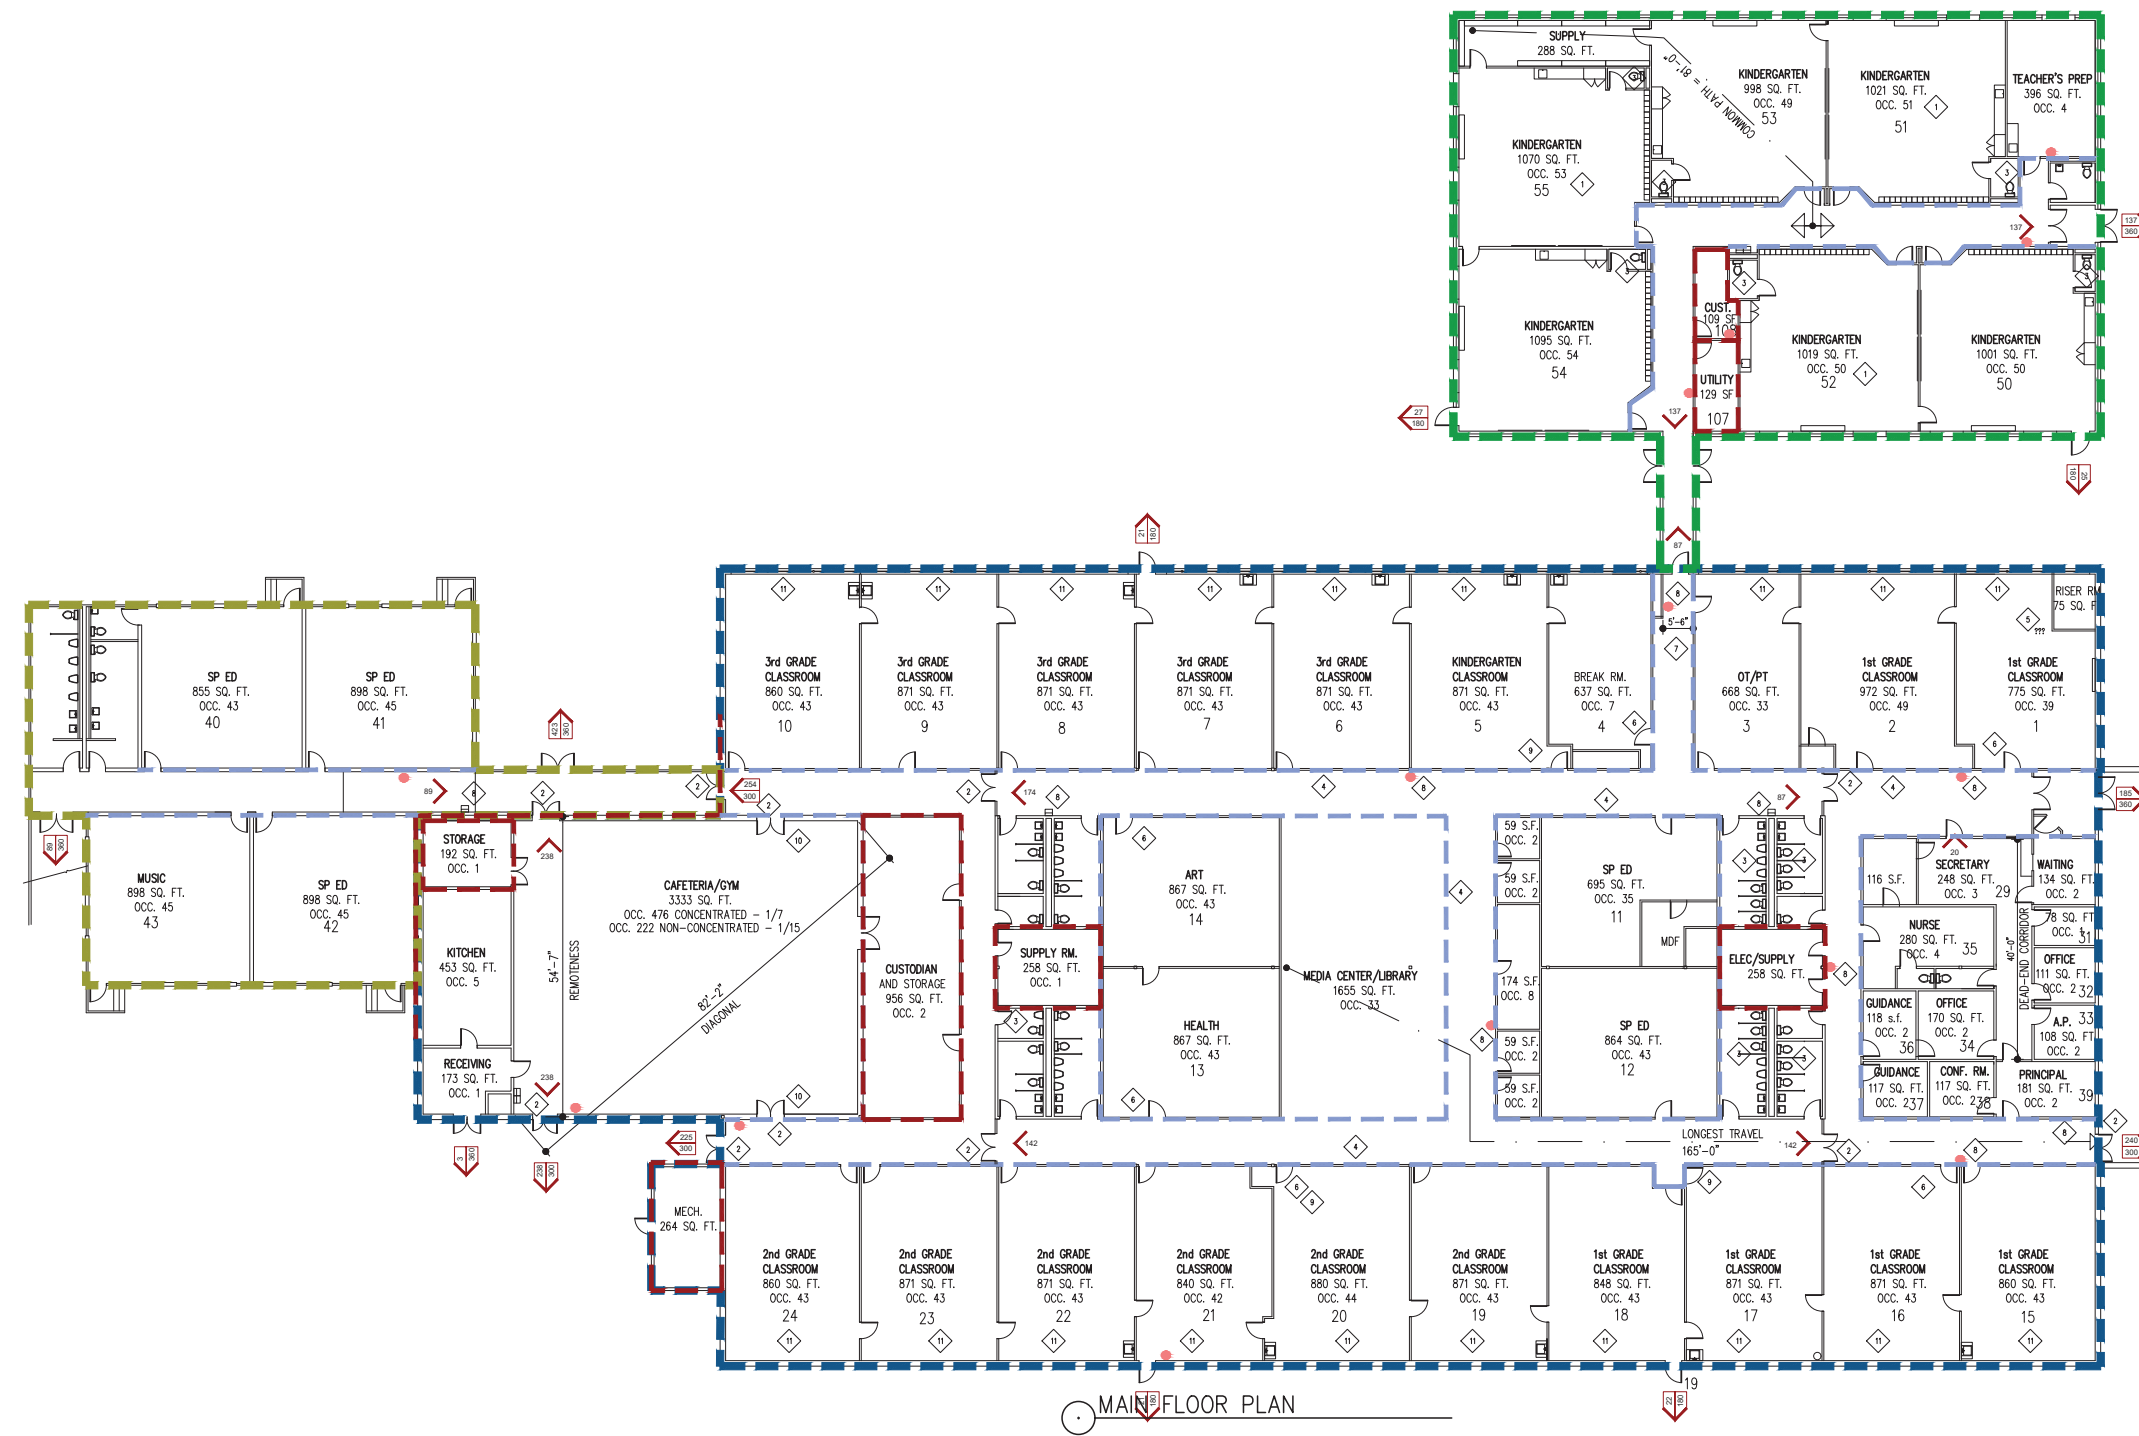
MAIN FLOOR PLAN

CODE NOTES	
1	ROOMS LARGER THAN 1000 SF REQUIRE 2 EXITS
2	MINIMUM EGRESS WIDTH OF 34" REQUIRED
3	ADA REQUIRES ACCESSIBLE FIXTURES
4	CORRIDORS ARE REQUIRED TO BE SMOKE RESISTANT
5	ROOMS ARE REQUIRED TO BE FIRE RATED
6	LIGHT SWITCH CANNOT BE REMOTE FROM ENTRANCE
7	MINIMUM CORRIDOR WIDTH 6'-0"
8	PROJECTIONS INTO PATH CANNOT EXCEED 4"
9	ADA REQUIRES MINIMUM CLEARANCES
10	DOORS W/ LOAD OVER 50 TO SWING IN DIRECTION OF EGRESS
11	PROJECTIONS AT WALKING SURFACES NOT LOWER THAN 6'-8"
12	
13	
14	
15
